## EVALUATION OF IMPOSED SAND DEPOSIT OCCASIONED BY FLOOD ON FARMS AT JIMETA-YOLA, ADAMAWA STATE, NIGERIA

The Benue River Basin provides more than 200 hectares of productive flood plain used for farming vegetables. Major flood events usually bring serious changes to the landscape, with large hectares of productive flood plains buried under thick deposits of river sand. This research was carried out to estimate the hectare of productive flood plains that had been buried under river sand along the Benue River basin in Jimeta, Adamawa State from the year 2014 to 2016. Gongola Topo-Sheet 156 NE (1:50,000) was used as the base-map, in addition to Google Earth images of the area for planning the field and sampling procedure. Satellite imagery and remotely sensed data were used to analyze the land use changes in the floodplain and further information on the sedimentation patterns. Results showed about 569,732m<sup>2</sup> (60 hectares) of farm lands under vegetable cultivation were buried under thick river sand following the flood event in 2012. This value decreased to 166,471m<sup>2</sup> and 136,037m<sup>2</sup> in 2014 and 2016, respectively. This showed the clear impact of sedimentat

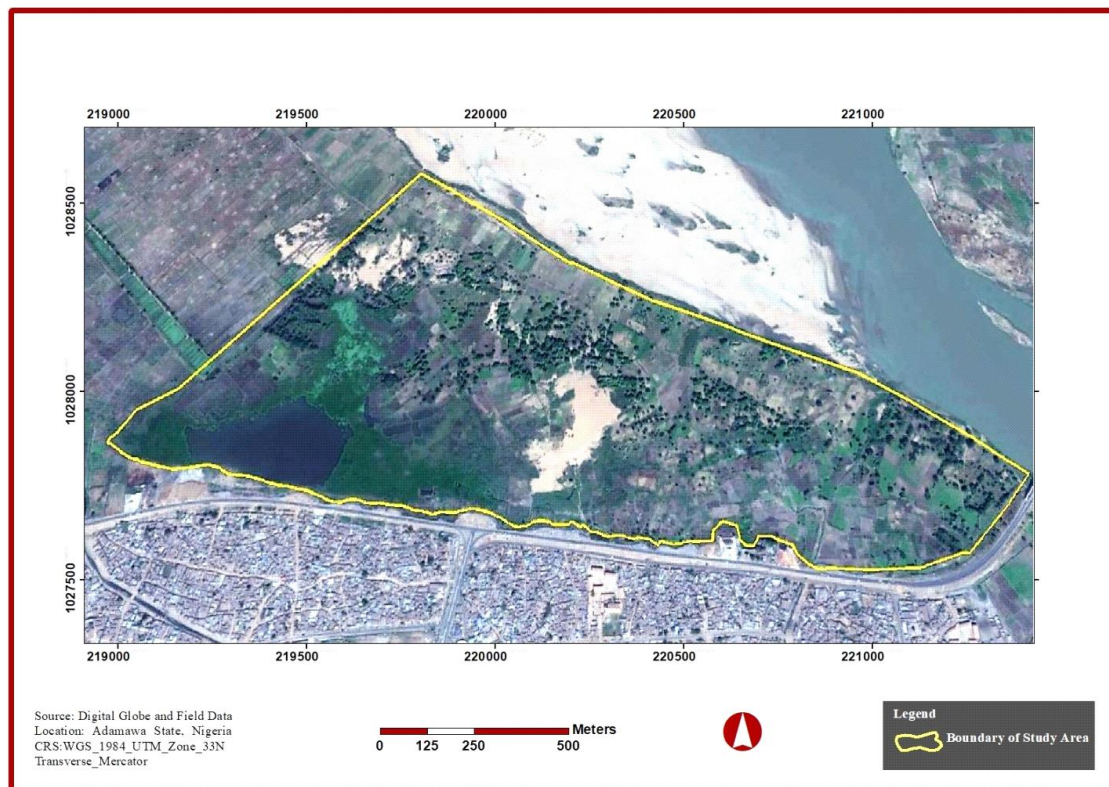
**Figure 1: Boundary of the Study Area**

In this study, the Gongola Topo-Sheet 156 NE (1:50,000) was used as a base-map, which was in addition to Google Earth images of the area that were used for the field planning work and sampling procedures (Fig 1). Satellite imagery and remote sensed data were used to analyze the land use changes in the floodplain, and information on the sedimentation patterns. A land area of 1,235,000 m<sup>2</sup> (123.5 hectares) of the flood plain was delineated using satellite images, and evaluated for change in land use and land cover at Jimeta-Yola from 2 years before the flood event in 2010 to four years after the flood event in 2016. The data for the various land use which includes the lake, sand deposit and cultivated land were obtained from remotely sensed data such as aerial photo and aerial photos as shown in the various figures presented during the period of the studies. Five satellite scenes of Landsat-TM in 2010, 2012, 2014 and one picture of 2016 were used.

The coordinate of the study area was used in obtaining the image of the study area on googleearth. The image was georeferenced, with the help of coordinates obtained from known features within the study area. The delineation of the area of interest was carried out on the georeferenced image through digitizing of the study area into shapefile.

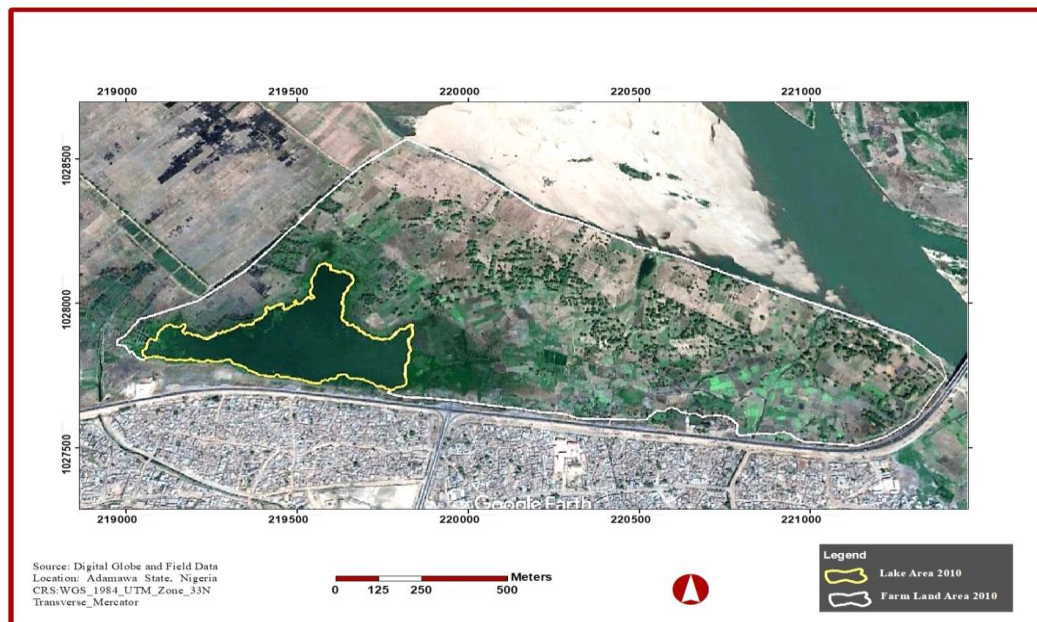
Figure2: Study area 2010

Results for the changes in land use and land cover (Table 2) showed that with satellite imagery, there were only two major land use types as at year 2010 (Figure 2) which was 2 years before the flood event. In the year 2010, about 109.5 hectares ( $1,094,504 \text{ m}^2$ ) of the total delineated area was being used for crop production, while the remaining 14.1 hectares ( $141,419 \text{ m}^2$ ) was water logged. However, following the flood event in the year 2012 (Figure 3), a third type of land use/land cover was formed which amounted to about 56.97

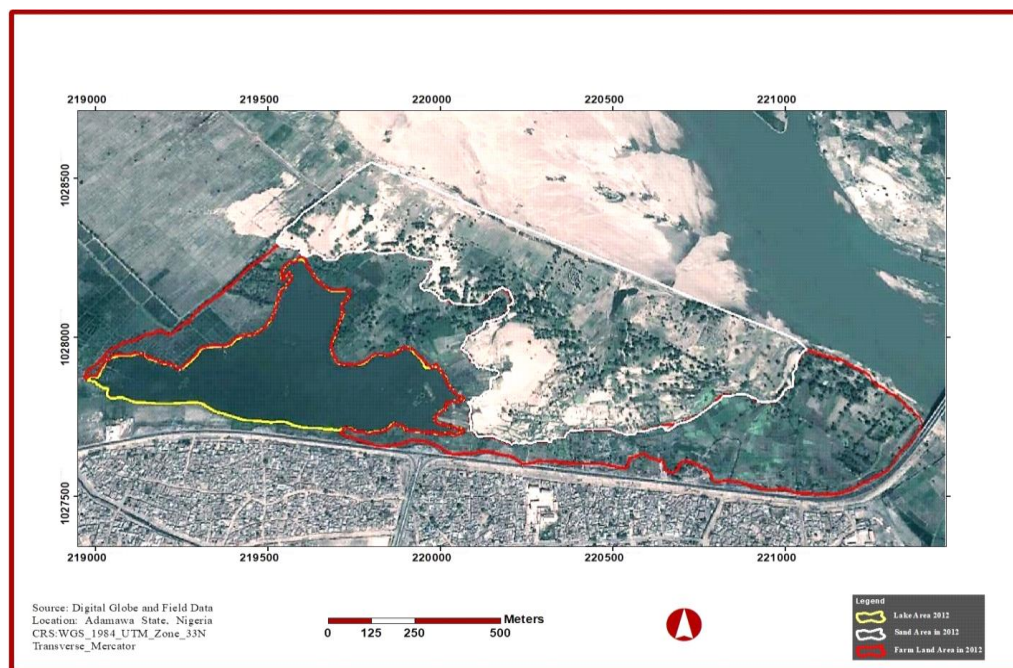
Figure 3: Study Area during Flood of 2012

hectares of the usually cultivated flood plains were buried under thick white river sand. Pathetically, area of the flood plains available for cultivation in 2010 that was made up of 88.62% (109.5 ha) of the total delineated study area (123.5 hectares), was reduced to just 43.5 ha after the flood event in 2012. This translates to a loss of more 60% of the land that had previously been available for crop production. It was also observed that in that same period, the area coverage of the water body (lake) increased by about 9 hectares ( $87.159 \text{ m}^2$ ), which indicates that, not all of the farmland was lost to sand cover. However, the flood had

The results obtained for subsequent years (fig. 3 and 5) suggested that a gradual decline in sand coverage and depth occurred and by the year 2016, only about 13.8 hectares

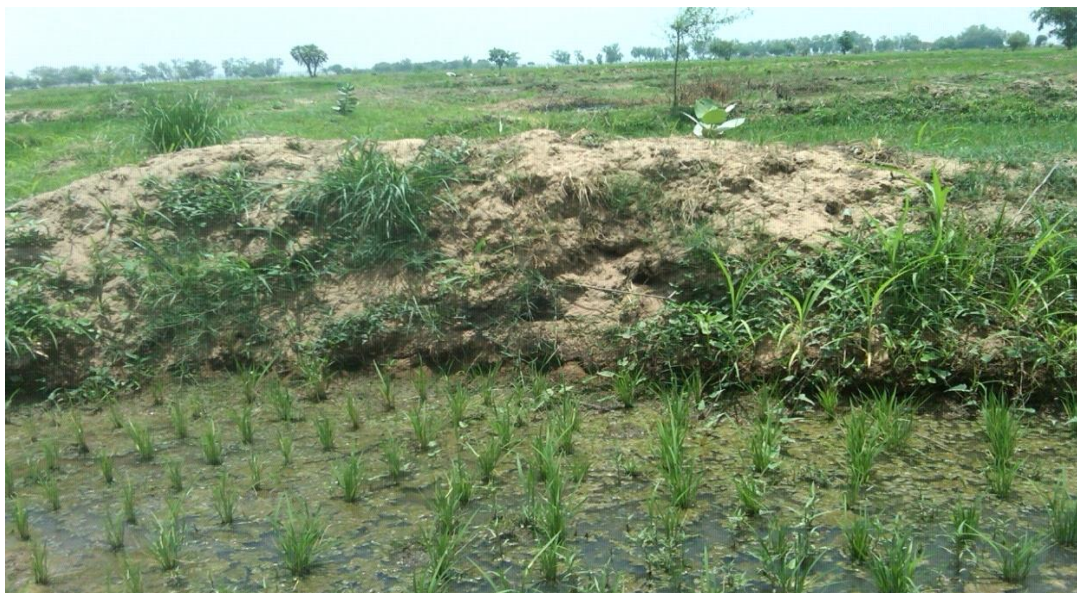
**Fig6: Excavation of sand deposit by local farmers**

Considering the management methods, Fig 6, shows some management methods being adopted by farmers in the study area due to sedimentation by river sand. Where light deposition occurs, the sands were gathered in heaps to expose the soil surface for cultivation. The sands were later transferred to dumpsites. This method had been adjudged to contribute immensely to the reduction of sands deposit problems in the study area, especially when all the farmers adopted such management practices.
